HVS-NORDIC

The activity of the second period in Finland 2000 - 2003

Finnra Reports 45/2003

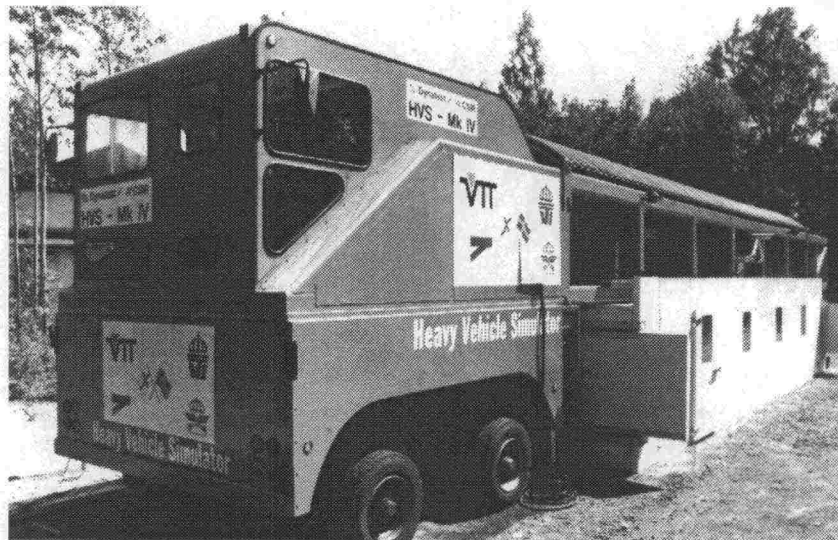
The machine is called HVS-NORDIC. The HVS Mark IV is a mobile full-scale accelerated pavement testing facility (Figure 1.1), whose loading is linear. It can be run over a short distance independently at walking speed, though in practice only at a specific test site. It can be moved as a semi-trailer over longer distances.

Figure 1.1. HVS-NORDIC accelerated pavement testing facility.

The HVS-NORDIC has a heating/cooling system and, thus, the temperature can be kept constant. The air temperature inside the heating/cooling box is controlled in order to keep the pavement temperature constant. The selected standard temperature of the bituminous layers was $+10^{\circ}\text{C}$.
